GFA AIRWORTHINESS DIRECTIVE

- TYPE AFFECTED:** STEMME S-10VT (Rotax 914 F2/S1 engine) Serial No's 11-001 up to & including 11-103.
- SUBJECT:** EXHAUST SYSTEM- INSPECTION FOR CRACKS.

STEMME F & D DO: EASA.21J.250	Service Bulletin <i>Inspection of exhaust-system for cracks</i>	Document Number: A31-10-075
		Am.-Index: 01.a

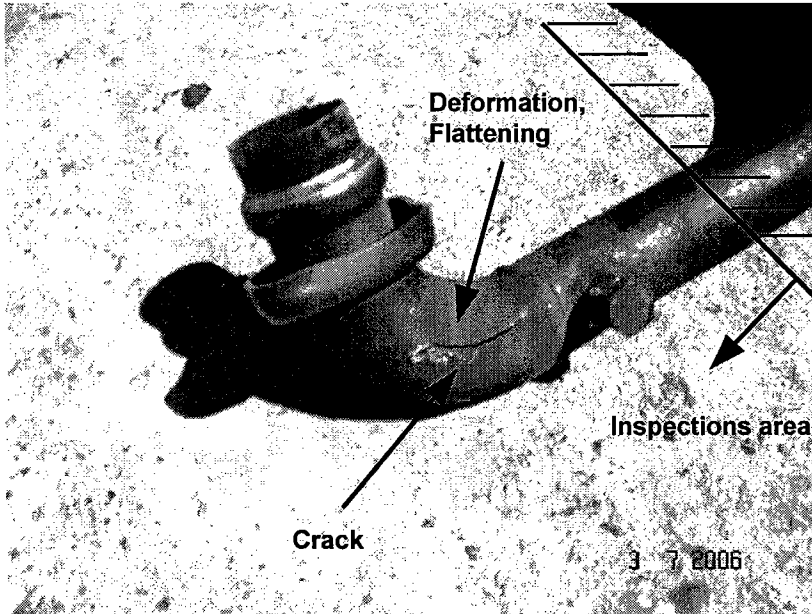
In an individual case deformations and cracks at an exhaust bend were found during maintenance work on the ROTAX 914 F2/S1. The defective exhaust bend was found on the thermally topmost loaded front-left cylinder. The damaged area is located in the curvature bend near the cylinder flange. Due to such a damage exhaust gases may expand into the engine compartment, or CO₂ may leak into the cockpit section.

- Remove the heat protection wrapping in the area of the curvature bends.
- Visual inspection of the exhaust pipes for deformations, cracks and flattening.
- In case of damages replace the concerned exhaust pipes.
- Recondition the heat protection wrapping (use only material which is approved by the manufacturer, see AMM S10-VT)
- Response of the findings to the manufacturer (see attached form)
