GFA AIRWORTHINESS DIRECTIVE

- TYPE AFFECTED:** DISCUS-2T Serial No's 1 to 40
DISCUS-2cT Serial No's 1 to 30
VENTUS-2cT Serial No's 1 to 179
- SUBJECT:** Cracks in Engine Mounting Pylon.

Technical Note No.

Engine mounting structure (pylon)

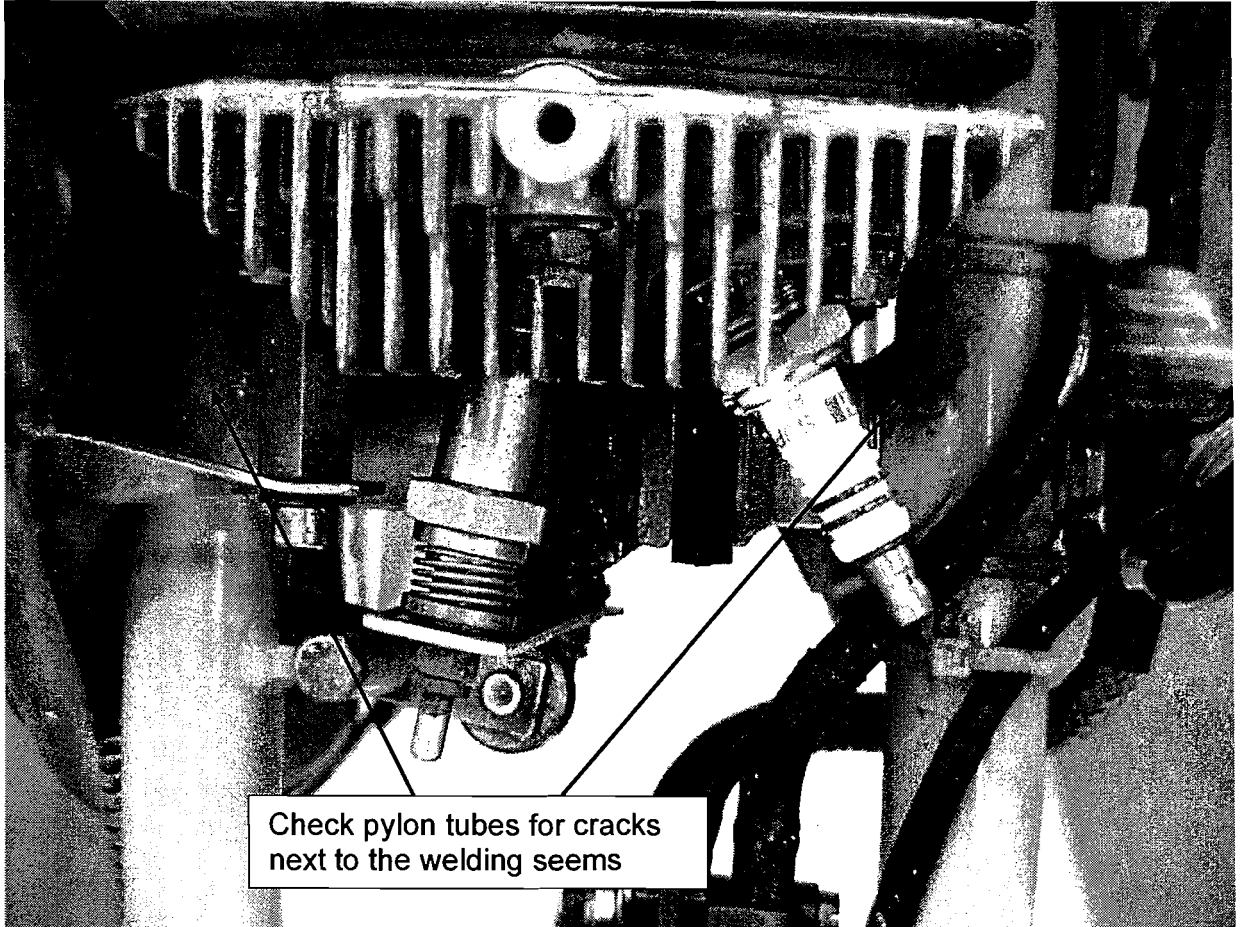
Front view of pylon

Check pylon tubes at the welding seams of the lower engine mount for cracks - see photographs enclosed to the Appendix of this Technical Note. Clean the affected areas at first if necessary.

If damage (cracking) is found, the pylon must be replaced. For this purpose the pylon must be removed and returned to the manufacturer. Please also forward the engine operation time of the affected pylon to the manufacturer.
