GFA AIRWORTHINESS DIRECTIVE

- TYPE AFFECTED:** STEMME S-10, Serial No's 10-03 up to 10-56.
 STEMME S-10V, Serial No's 14-001 up to 14-030.
 STEMME S-10VT, Serial No's 11-001 up to 11-100.

- SUBJECT:** Inspection of brass fuel connectors.
- REASON:** A leaking brass fuel connector was found during routine maintenance work. The brass connectors were introduced with SB A31-10-061 and SB A31-10-063. The brass connectors were subsequently used in serial production and supplied as spare parts. The leaking connector was of the original design, identified as "Index 01.a" and was used from Feb 02 to April 02, when a new design was introduced, identified as "Index 02.a"

STEMME	Service Bulletin	Document Number: A31-10-077
F & D	<i>Fuel Connector – hose connector 10AB-75</i>	Am.-Index: 01.a
DO: EASA.21J.250		Page: 4 of 6

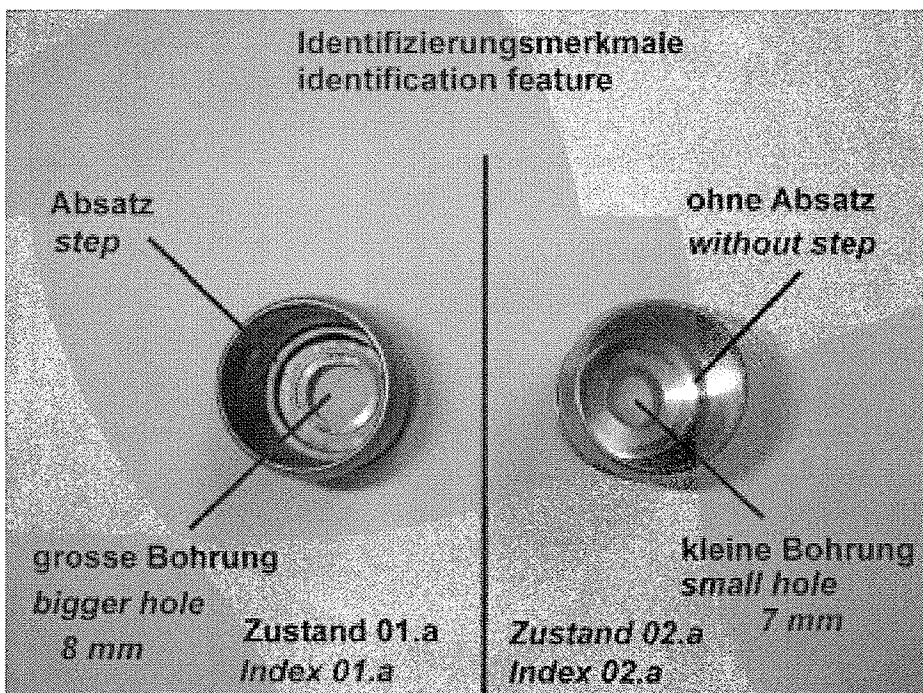
The leaking brass connector was according to the design modification index 01.a. It was valid for the period February 2002 until April 2002. A modified version of the hose connector was introduced in April 2002, after the old version turned out to be susceptible to improper assembly and maintenance work. The modified version has the design modification index 02.a.

- disconnect the quick-type fuel connectors between the wing and the fuselage
- If the fuel tanks are not empty, a second person should push down the wing to be inspected by hand. No fuel must be visible inside of the yellow "Tygon"-hose.
- unscrew the clamp for the hose connector 10AB-75
- visual identification of the design modification index of the hose connector according to the picture:

- if the **design modification index 01.a** will be identified: next step must be **action 3**.
- the existing fuel connector may be reassembled with the existing clamp if the design of the hose connector 10AB-75 confirms with modification index 02.a
- Inspection for tight mounting and leak tightness
- repeat action 2 (identification of installed version) for the other side of the wing

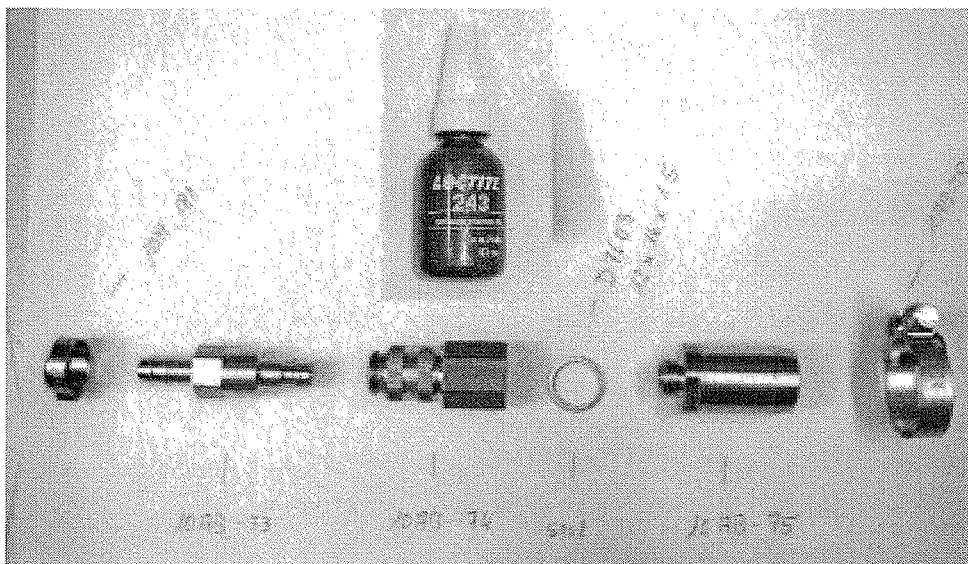
Action 3: replacement of hose connectors of modification index 01.a by connectors of modification index 02.a

- Disassemble the old hose connector 10AB-75 from the quick-type fuel connector by heating it up slightly (Loctite was used during assembly), then unscrew the quick-type fuel connector from the hose connector
- the sealing ring and the connector must be mechanically cleaned (brass brush)
- assemble the new hose connector (design modification index 02.a) with Loctite 243 (fastening torque 10Nm / 7.38 lb.ft.)
- install the new connector with the clamp
- Inspection for tight mounting and leak tightness
