## GFA AIRWORTHINESS DIRECTIVE

- SUBJECT:** Inspection of engine Magnetic Plug.
- REASON:** In a few cases, increased wear of camshaft / hydraulic tappets has occurred. This can lead to improper engine operation, power loss or in flight engine failure.

**ALERT SERVICE BULLETIN**  
**CHECKING OF MAGNETIC PLUG**  
**ON ROTAX® ENGINE TYPE 912/914 (SERIES)**  
**ASB-912-051**  
**ASB-914-034**

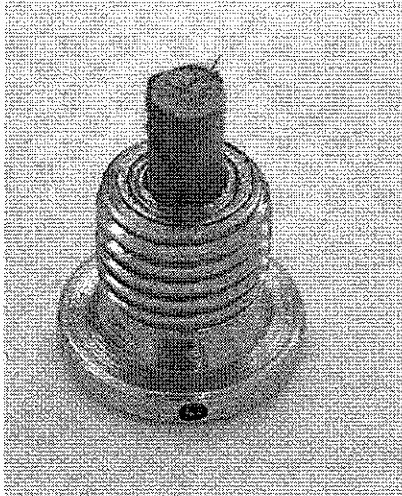
fig. 1

acceptable

■ **CAUTION:** If a greater quantity of metal particles (more than 3 mm (1/8")) is detected, consultation of an authorized distributor regarding further action is necessary. The engine must not be taken into operation until the cause has been identified and eliminated.

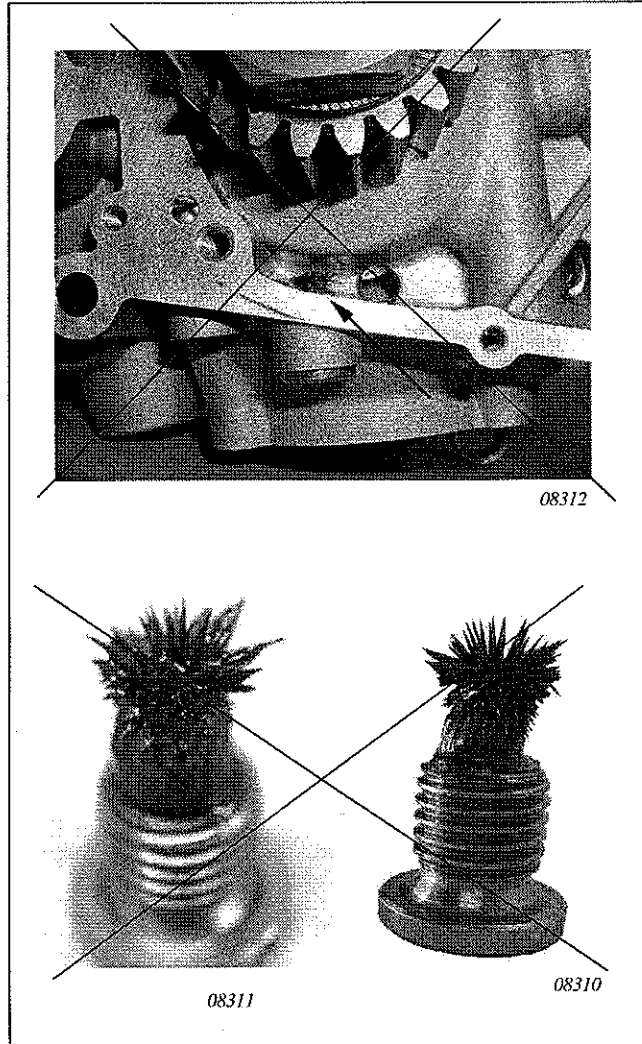
fig. 2

not acceptable
