GFA AIRWORTHINESS DIRECTIVE

- TYPE AFFECTED:** SZD-50-3 PUCHACZ:- All aircraft up to Serial No B-2207 and serial No's 503199327, 503A04001, 503A05002 & 503A05003
- SUBJECT:** Flight Controls: Inspection / replacement of airbrake intermediate (Vee shaped) bellcrank mounting bolt & lockwasher.

GFA AD-655 ISSUE 1 PAGE 2 OF 4

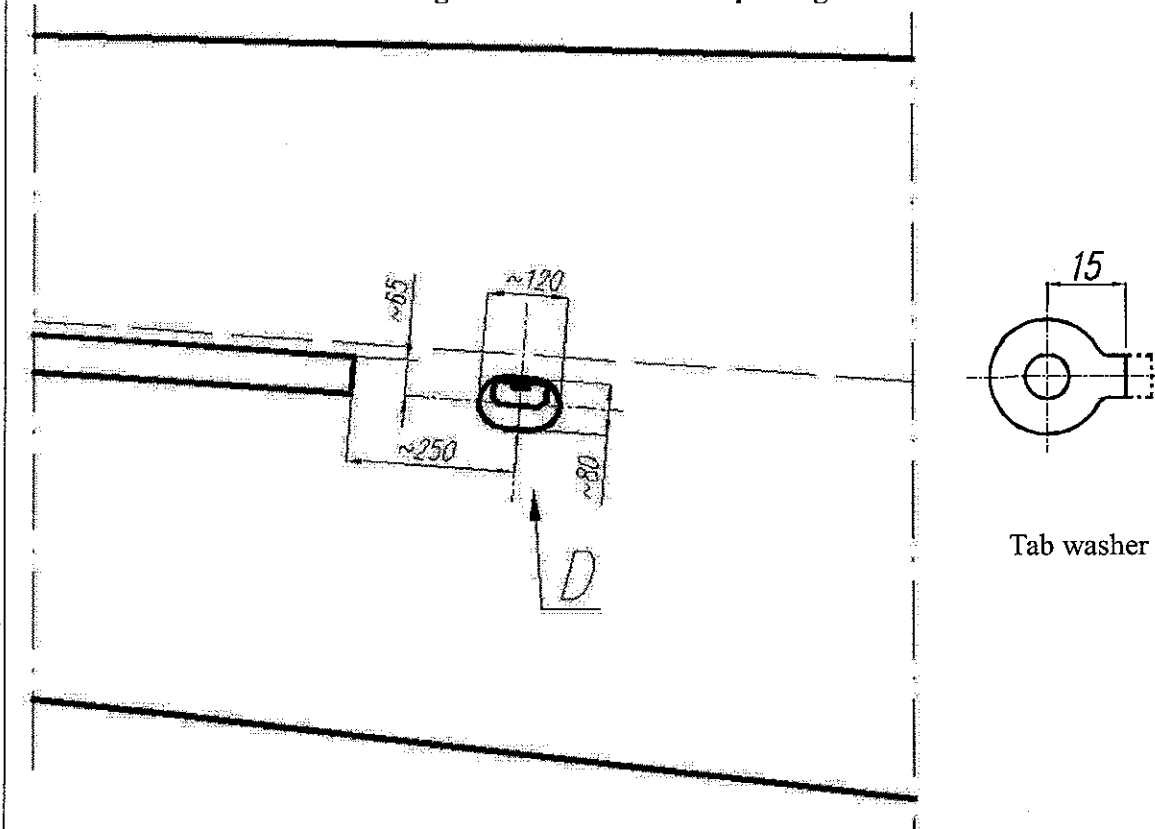
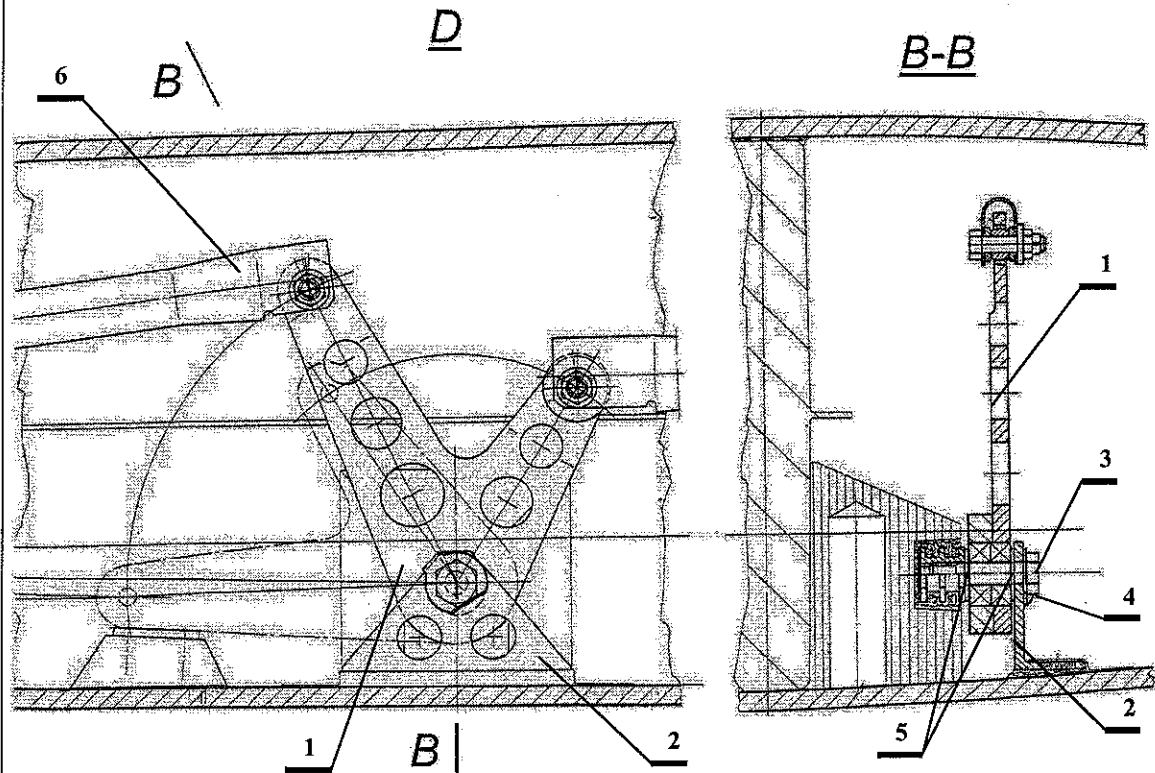
Fig. 1. Bolt and washer replacing.

- REASON:** Experience has shown that the mounting bolt in the right wing may become loose resulting in an inability to retract the airbrake on that wing. The left wing can be similarly affected although no instances of difficulty have been reported so far.

- 6.1. De-rig the wing.
- 6.2. Cut a hole in upper skin of the wing, according to Fig. 1.
- 6.3. Screw out and remove bolt M8x34, remove also spring-lock washer and spacer washers (5).
- 6.4. Screw in bolt M8x32 (3), with a tab washer (4) as a locking device, inserting also spacer washers (5) on their place.
- 6.5. Bend a tab of the tab washer (4) on the lever console (2) as shown in "D" view. Bend tab washer on the bolt (3) head, at arbitrary selected position.
- 6.6. After ensuring that assembling has been performed correctly, and bolt reliably locked by tab washer bent, repair the hole in wing skin according to Repair Manual of the glider.
