AIRWORTHINESS ADVICE NOTICE

TYPE AFFECTED: Standard Austria SH1.

SUBJECT: Miscellaneous airworthiness information.

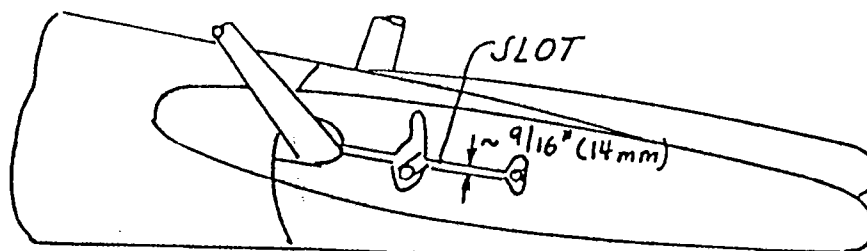
FIGURE 1 INSPECTION SLOT

To facilitate the remove of the tail cone for further inspections, it is advisable to cut slots into the cone for the protruding bolts to pass through, as on later models SH1 and on the SHK.

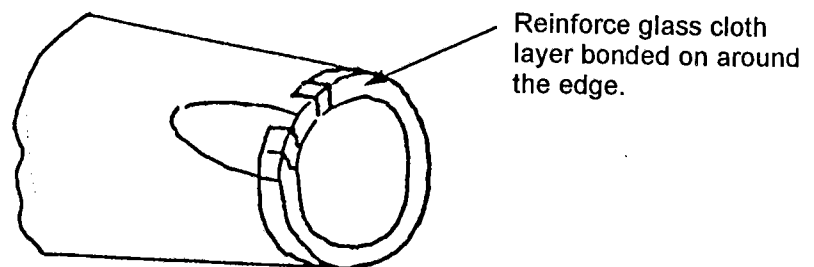
FIGURE 2

Reinforce glass cloth layer bonded on around the edge .

After the hardening of the glue joint reinforce the bulkhead-fuselage joint by means of two glass cloth layers (at least 3 inches wide) bonded with epoxy resin.

Apply the resin and put on the first glass cloth layer with diagonal weave direction and follow with the second layer. each layer must be thoroughly penetrated with resin (no white spots should show).

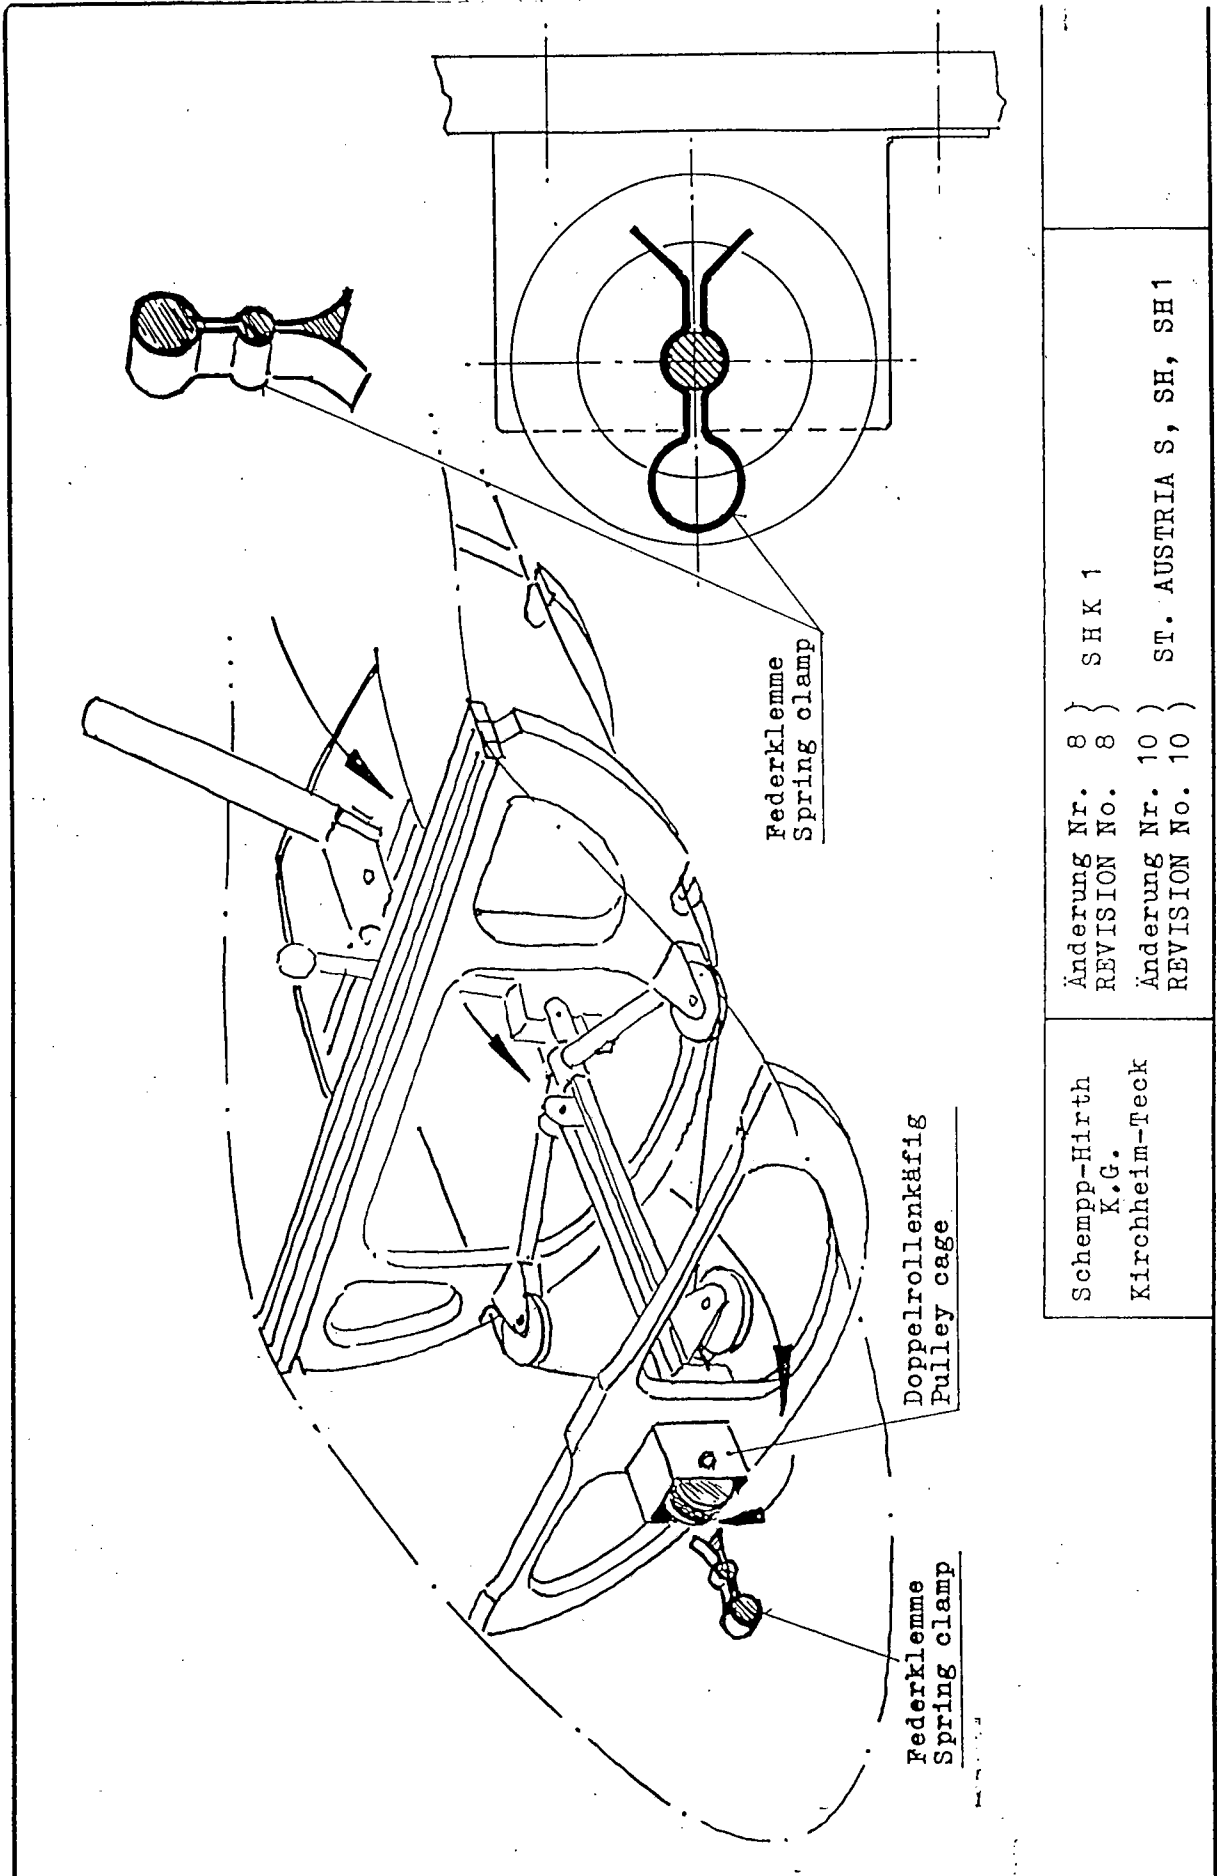
FIGURE 3

Cause: It happened in one case that the ball-bearings of above mentioned pulleys-became loose. The result was an insufficient guide of the rudder control cables. Since the pulleys are kept in place only by a bushing between the internal ball-bearing rings, measures are to be taken to keep the entire pulleys in place.

Measures: In order to avoid the rather difficult removal of the pulley cage in the fuselage nose, a spring clamp has been provided, which is but to be inserted onto the bushing between the ball-bearings of the pulleys.

Follow the instruction of the Figure 3, which belongs to this revision.
