# THE GLIDING FEDERATION OF AUSTRALIA INC.

## AIRWORTHINESS ALERT 2010-1

### ASK-21 Sailplanes & ASK-21 Mi Powered Sailplanes

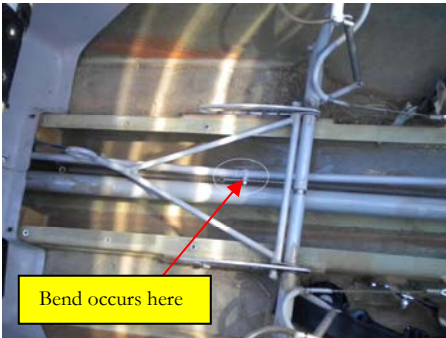
On Monday 12 July, during the performance of the Pre Take-off checks, an ASK-21 sailplane was found to have restricted movement of the controls. The restriction was caused by a bend in the pushrod connecting the front & rear trim levers. This resulted in the pushrod being displaced downwards into an area normally occupied by the aileron/elevator control tube, preventing it from moving left towards the wooden stop shown in the picture to the right. This caused blocking of right aileron travel and could have led to loss of control had it occurred during flight. Discovery of this problem while on the ground proves the value & importance of a properly conducted Pre Take-off check.

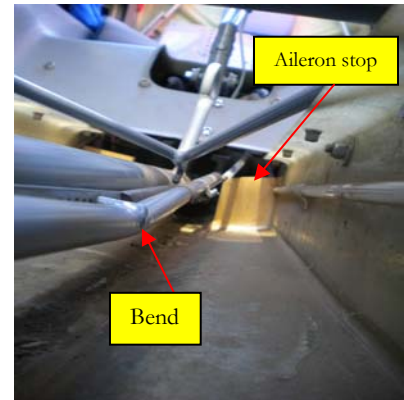
The damaged rod can only be seen once the cockpit floor panel forward of the rear seat has been removed. It

is not known for certain how the damage occurred, but high compressive loads could be generated in the pushrod by overtravel of the front trim lever once the trim has reached its forward limit, as the stops are incorporated at the rear. The pushrod has a stud welded on the top side for attachment of the trim springs. Shrinkage caused by the welding process will result in a slight downward bow and probably some local softening of the tube. Excessive compression loads would result in distortion at this focal point.

**It is highly recommended that the trim pushrod be inspected for damage before further flight.**

Inspection requires removal of the cockpit flooring panel forward of the rear seat. A 300 mm straight edge held against the pushrod underside will show any bend. Bear in mind that there may be a slight bend from new, but with the straight edge held centrally beneath the welded stud this should not exceed 1 mm at one end of the straight edge while the other end is in contact with the tube. With the trim in full forward, full rear and mid range positions, check throughout the full movement range of elevator & aileron controls that the trim pushrod does not contact the aileron/elevator control tube or the wooden aileron stop.

**If excessive bending of the trim pushrod, or interference to the travel of the aileron/elevator tube is found, the aircraft is to be immediately withdrawn from service and this office notified.**

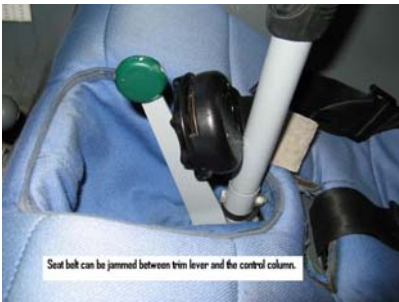
There are at least two ways that excessive load could be applied to the trim lever. The picture to the left shows how it is possible for the front harness buckle to lodge between the front stick and the trim lever. Forward movement of the stick, or more likely the rear stick, would exert significant pressure on the trim lever, resulting in very high compression loads in the pushrod connecting the two trim levers. Similar loads could also be applied if an occupant entering the front cockpit in an awkward manner accidentally put a foot on the front trim lever.
