GFA AIRWORTHINESS DIRECTIVE

- TYPE AFFECTED:** H-201 STD LIBELLE, H-201B STD LIBELLE,
H-202 SD LIBELLE, H301 LIBELLE, H-301B LIBELLE.
(German Type Cert No 251.)
- SERIAL No's Affected:** ALL

- SUBJECT:** Replacement of Rudder Gimbal Drive, rear actuator arm.
- BACKGROUND:** Damage, resulting in failure of the actuator arm, can be caused by improper lifting of the rear fuselage by the rudder, or following severe rear fuselage damage.

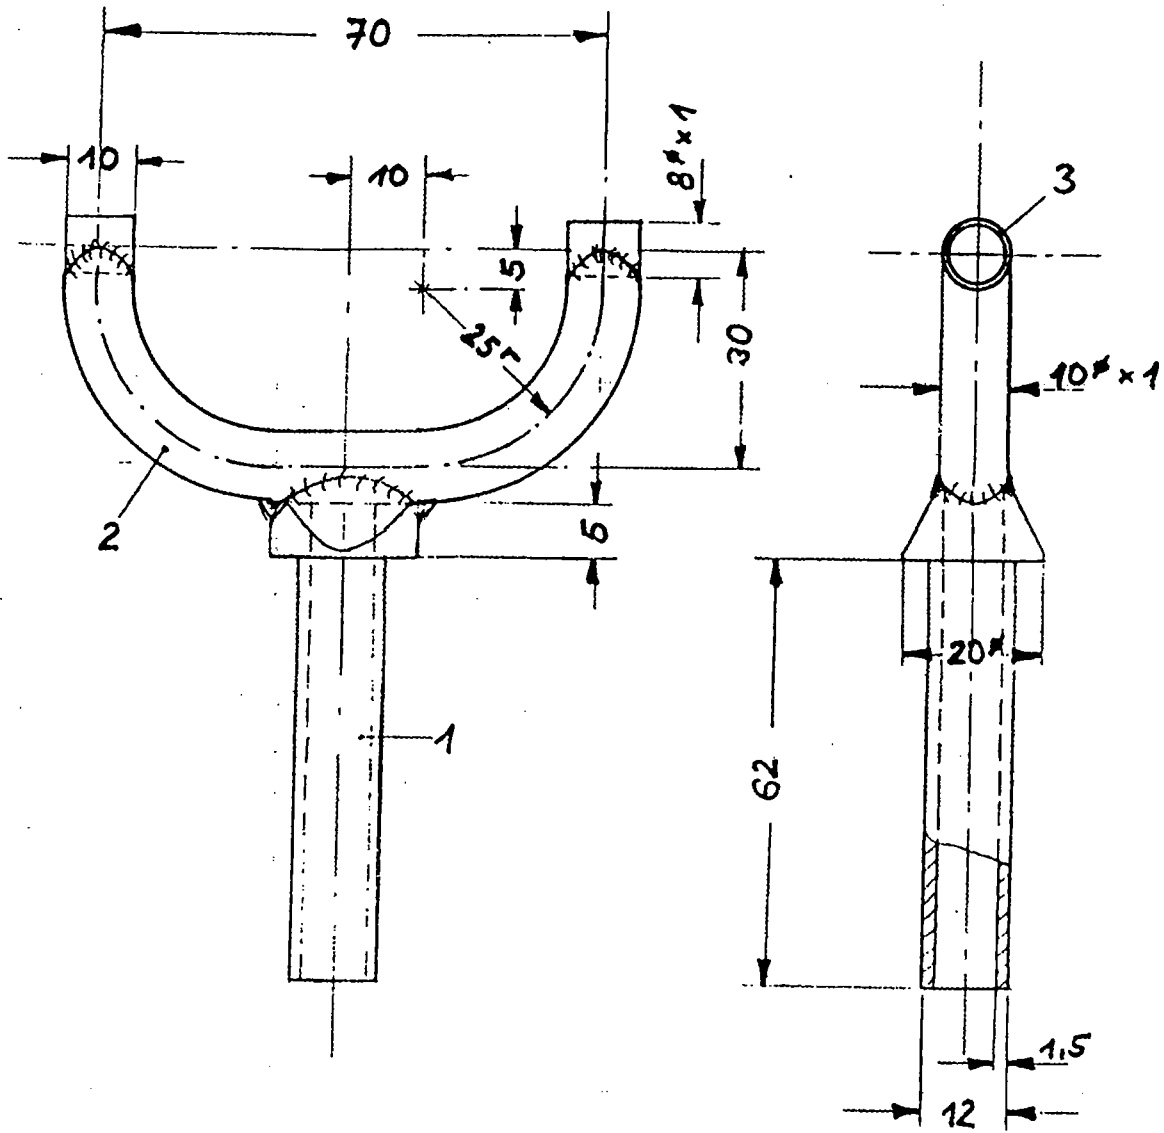
Bei nicht tolerierten
DIN 7168 Genauigkeitsgrad m.m.l.

Im WIG-Verfahren mit Zusatzwerkstoff 1.7734.2 geschweißt. Grundiert mit Wash-Primer 42002 + Härter 40018. Decklackierung mit Nitro-Lack grau RAL 7003.

Spannungsfrei gegläht
bei 580°C 4 Std.
unter Schutzgas

- DOCUMENTATION:** The LBA has issued AD-2005-118. Glasfaser-Flugzeugbau has issued Technical Notes No's. 301-39 & 201-35 (combined document) and Drawing No. 301-45-13. These documents are attached to and form part of this AD.

- ACTION REQUIRED:** In accordance with the above Technical Note replace the actuator arm type 301-45-10 with the improved version type 301-45-13.
- WEIGHT AND BALANCE:** Nil effect.
